# Site Accessibility Evaluation

### University Facility Evaluation

**UC Berkeley  
Berkeley, CA 00000**

**Accessibility Evaluation**

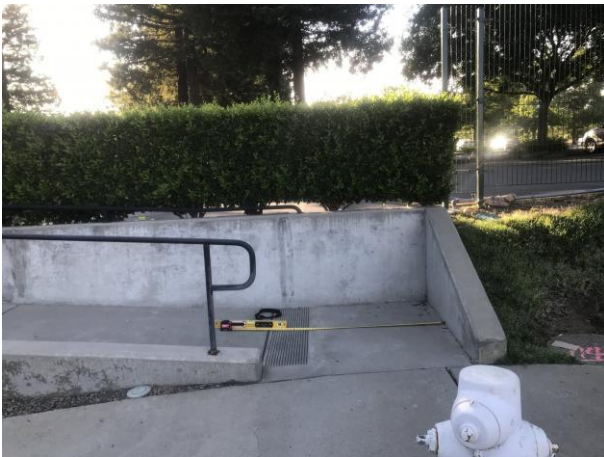
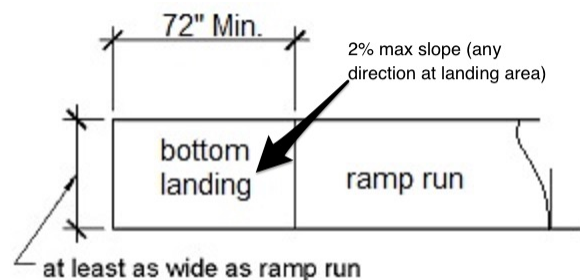
### Finding: 1

The bottom landing does not provide the minimum area required.

The bottom landings shall extend 72 inches minimum in the direction of ramp run and shall be at least as wide as the widest ramp run leading to the landing.

2019 CBC 11B Section: 11B-405.7.2,  
11B-405.7.3.1

60 inches

Modify landing at least meet minimum requirements for length.

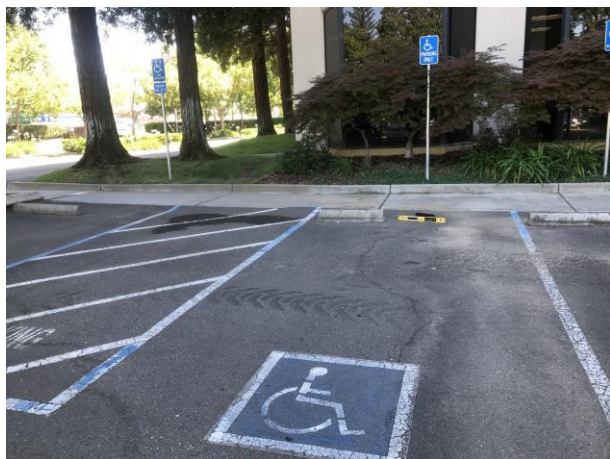
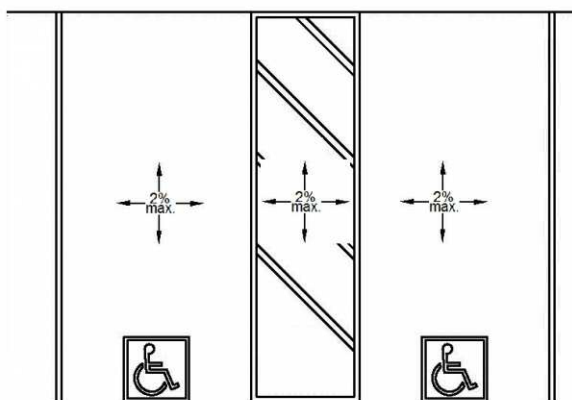
### Finding: 2

The cross slope (narrow dimension) of the parking stall exceeds 2%.

The running and cross slope in an accessible parking stall and the access aisle must not exceed 2%.

2019 CBC 11B Section: 11B-502.4

2.4% to 3.4%

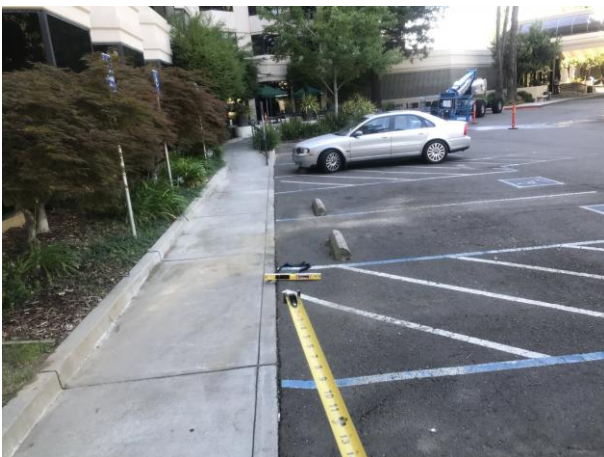
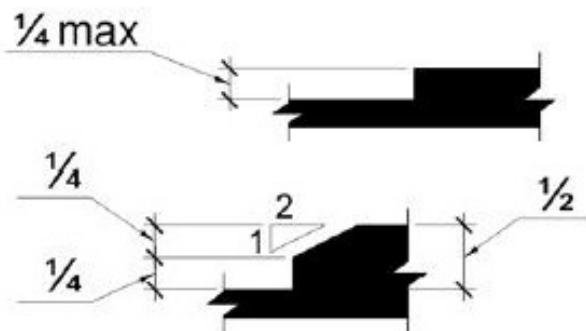
### Finding: 3

The walkway contains abrupt vertical edges and/or variations over a 1/4 inch.

1/4 inch is the maximum vertical rise. Changes in level between 1/4 inch and 1/2 inch must be beveled at 1:2 or less.

Changes in level greater than 1/2 inch must be by way of a ramp.

| Citation: | As Built: | Budgeting Range: |
|---|---|---|
| 2019 CBC 11B Section: 11B-303.2, 11B-303.3 | 1 1/4 inches | \$1,500 - \$4,500.00 |

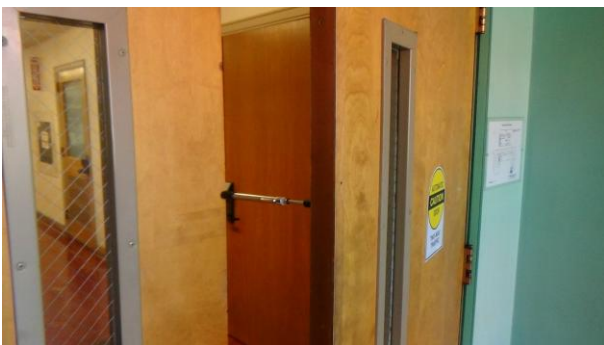
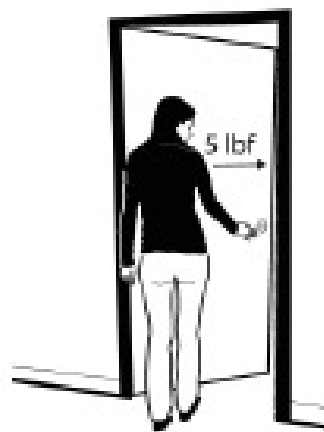
### Finding: 4

The door exceeds the maximum force to open.

Doors shall have a maximum opening force of 5 pounds.

2019 CBC 11B Section: 11B-404.2.9

10 lbs / 3.5 second  
backcheck

Adjust closer to require no more than 5 pounds of force to open.

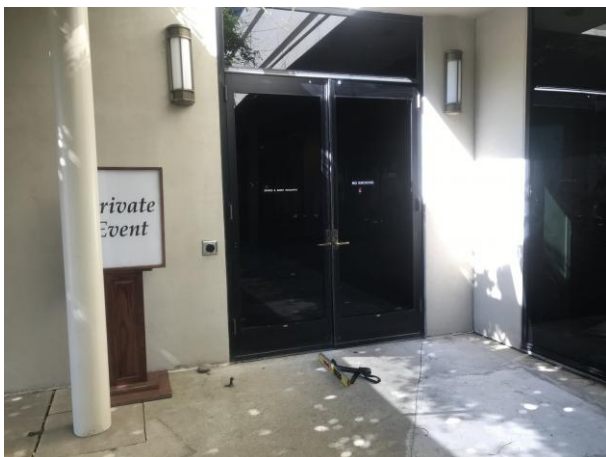
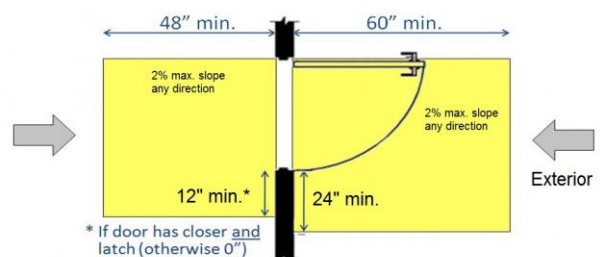
### Finding: 5

The landing at the entrance door exceeds 2% slope.

Exterior doors must have a landing on the pull side that is a minimum of 60 inches in depth perpendicular to the door in a close position by a minimum width dimension of 24 inches plus the door width. The additional 24 inches must extend past the door on the latch side. The entire landing must be free of obstructions and must be flat (2% max. slope is considered flat in any direction).

2019 CBC 11B Section: 11B-404.2.4.4

2.4% to 3.3%

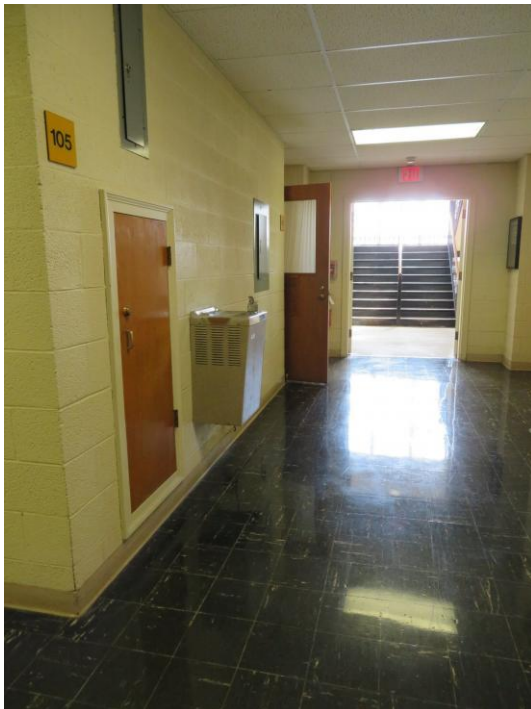
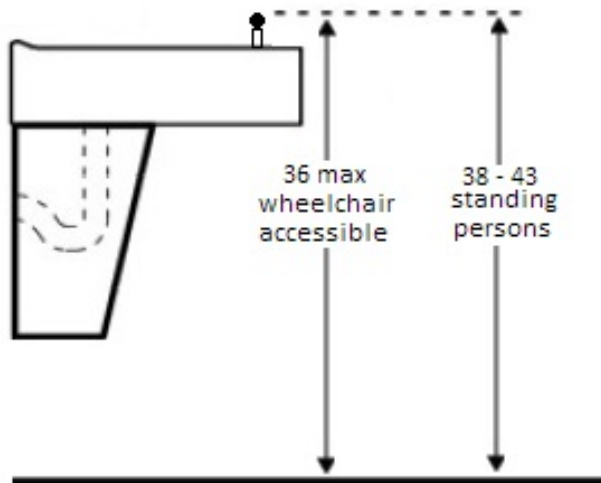
### Finding: 6

The total number of drinking fountains are not equally divided between those that are accessible to wheelchair users and those that are available to standing persons.

Where more than two are provided, 50 percent of the total number of drinking fountains provided shall be accessible to wheelchair users and 50 percent available to standing persons.

2019 CBC 11B Section: 11B-211.3

Missing wheelchair accessible drinking fountain

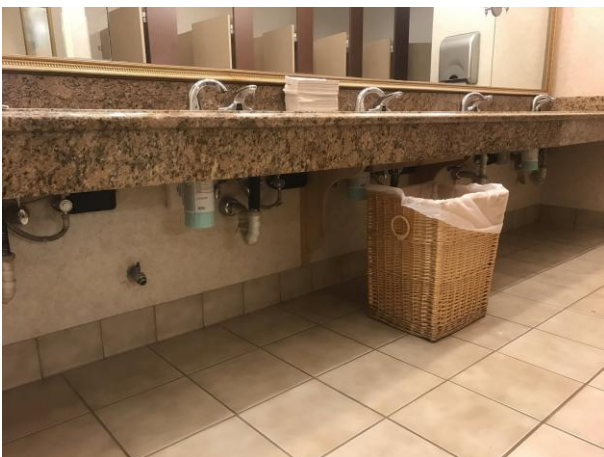
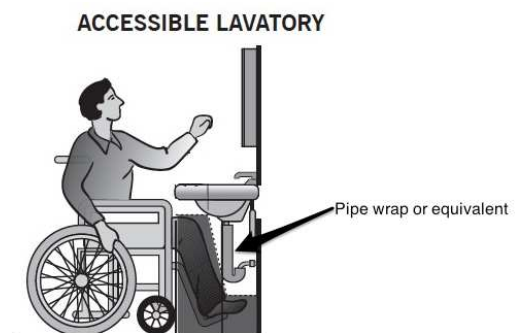
### Finding: 7

The water and drain pipes under the lavatory are not adequately insulated.

Water supply and drain pipes under lavatories and sinks shall be insulated or otherwise configured to protect against contact. There shall be no sharp or abrasive surfaces under lavatories and sinks.

2019 CBC 11B Section: 11B-606.5

Missing

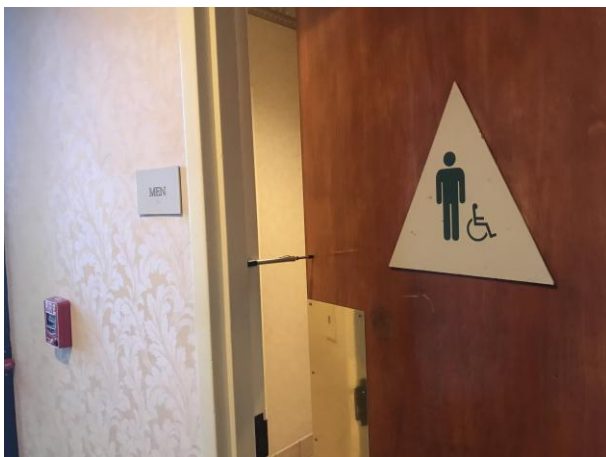
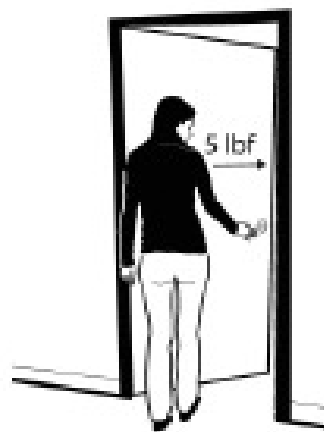
### Finding: 8

The door exceeds the maximum force to open.

Doors shall have a maximum opening force of 5 pounds.

2019 CBC 11B Section: 11B-404.2.9

12 lbs / 3.2 seconds

Adjust closer to require no more than 5 pounds of force to open.

Corrected by maintenance on 6/29/2019

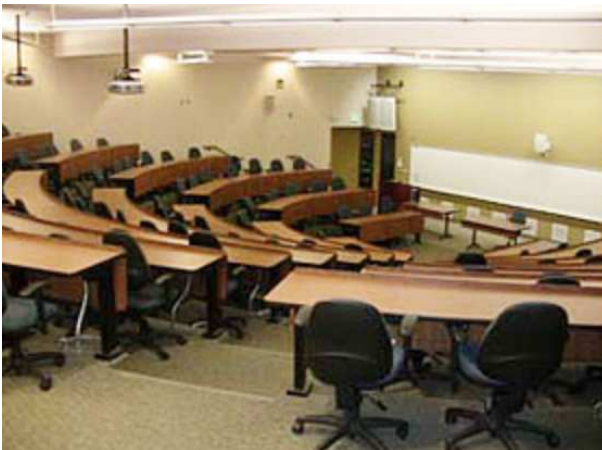
### Finding: 9

Based on the number of seats provided in this area 55, there should be a minimum of 4 wheelchair seating spaces.

Wheelchair spaces shall be provided in assembly areas with fixed seating.

2019 CBC 11B Section: 11B-221.2,  
11B-221.2.1.1

None provided

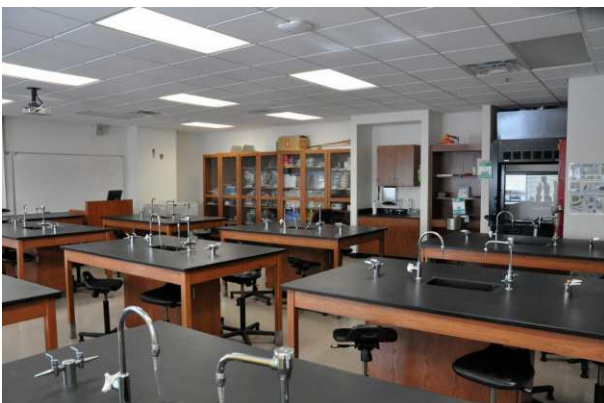
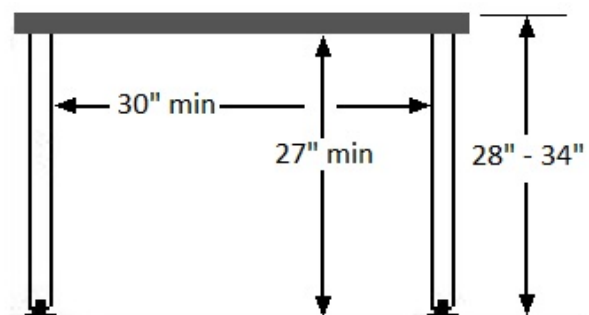
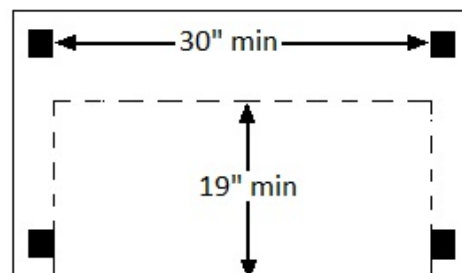
### Finding: 10

There are no accessible work surfaces.

At least 5% of each type of work surface must be accessible and must be dispersed throughout the space or facility containing work surfaces. The accessible surface must be on an accessible route (36 inches minimum) and have knee and toe spaces at least 27 inches high, 30 inches wide and 19 inches deep. The tops of work surfaces shall be 28 inches to 34 inches from the floor or ground.

2019 CBC 11B Section: 11B-226.1

None provided

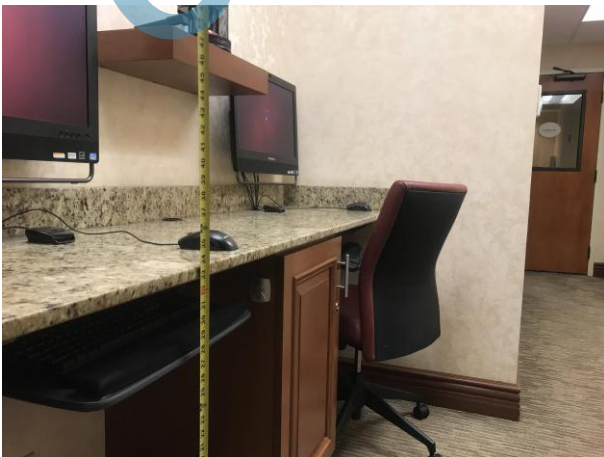
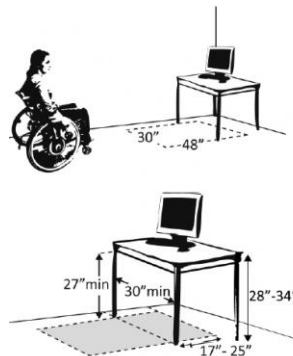
### Finding: 11

Compliant knee clearance is not provided at the accessible table.

When seating for persons in wheelchairs is provided at fixed tables or counters, knee spaces at least 27 inches high, 30 inches wide and 19 inches deep shall be provided.

| Citation: | As Built: | Budgeting Range: |
|--|---|---|
| 2019 CBC 11B Section: 11B-306.3.3 | 25 inches | \$150 - \$1,500.00 |

Replace or modify the work station table to allow the at least the minimum clearance required.

Maintenance raised the desk 2 1/2 inches. Knee clearance is now at 27 1/2 inches.
