Site Accessibility Evaluation

Americans with Disabilities Act And Title 24 And Part 2 - California Building Code

**Street A @ Street B
PU19-0044**

Public Right of Way

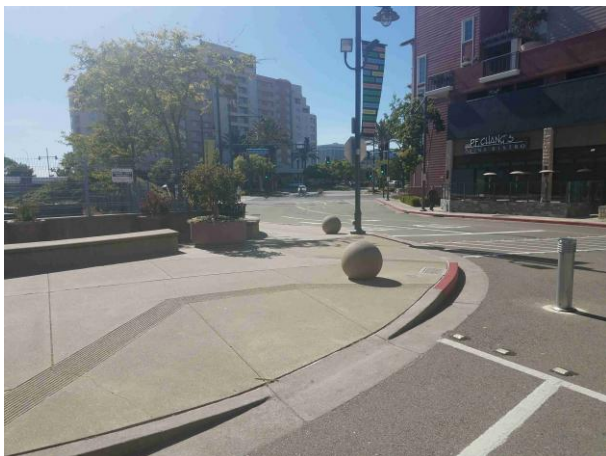
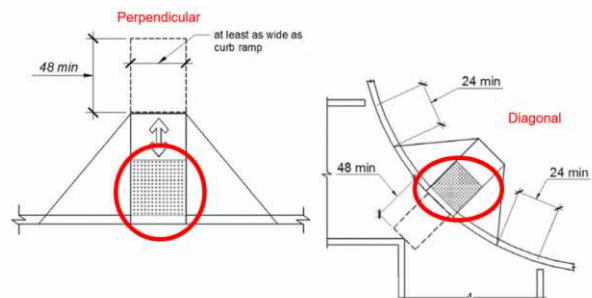
Finding: 1

The detectable warning is missing at the curb ramp.

Detectable warnings at curb ramps shall extend the full width of the ramp run less 2 inches maximum on each side, excluding any flared sides and 36 inches in the direction of travel.

2019 CBC 11B Section: 11B-247.1.2.2,
11B-705.1.2.2

Missing

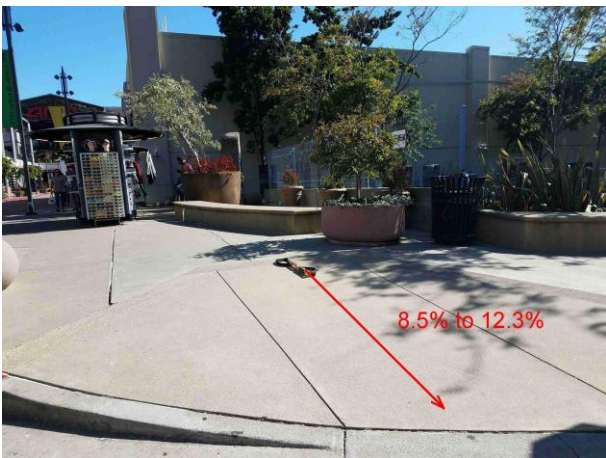
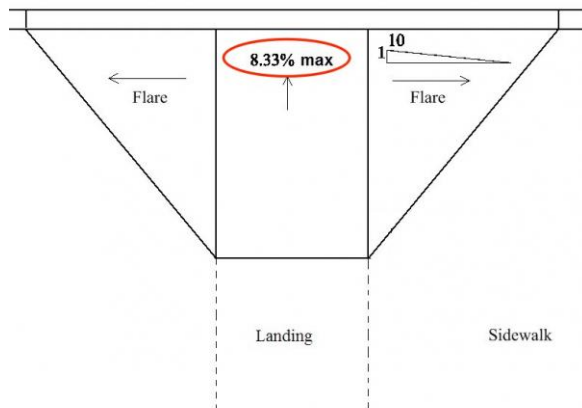
Finding: 2

The curb ramp slope exceeds the maximum running slope (Parallel to the direction of travel) allowable of 8.33%.

Curb ramps should have the least possible slope but in no case more than 8.3% (1:12).

2019 CBC 11B Section: 11B-406.3.1

8.5% to 12.3%

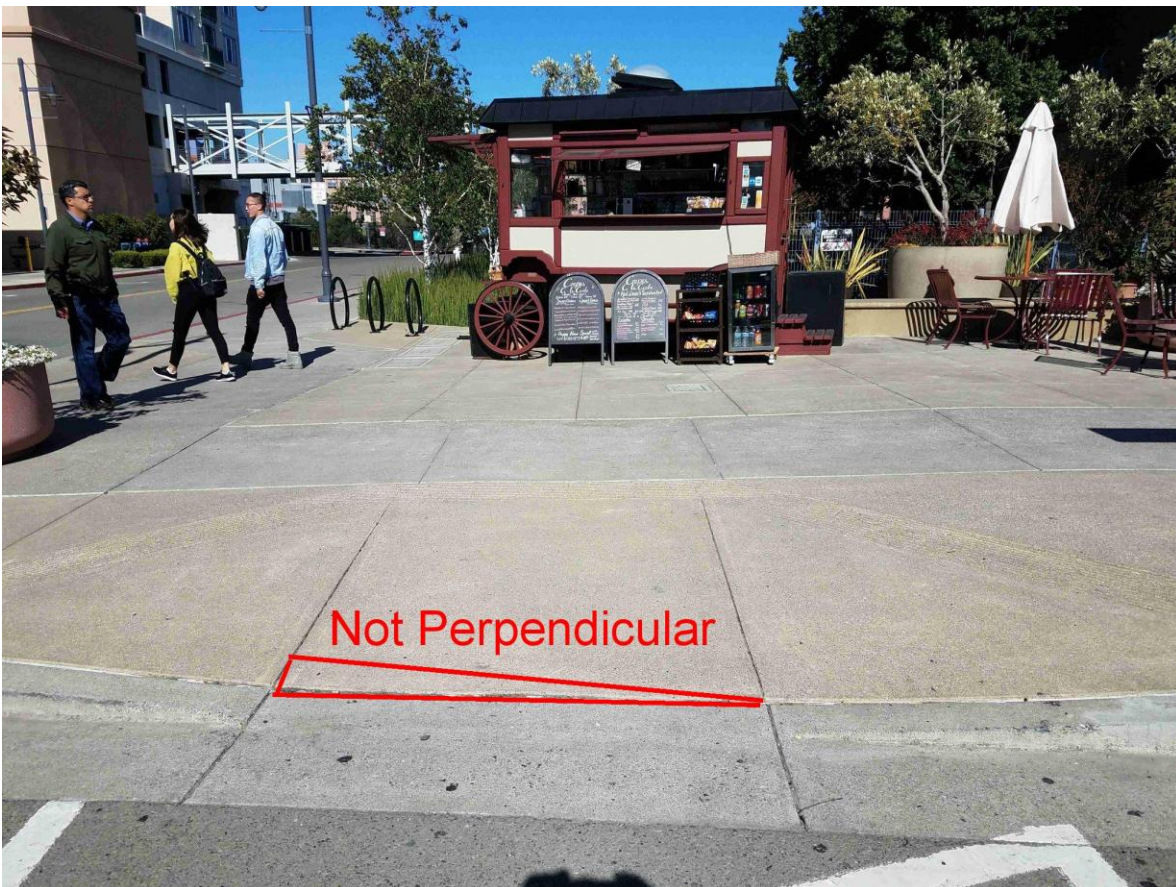
Finding: 3

The grade break at the bottom of the ramp is not perpendicular.

Grade breaks at the top and bottom of curb ramp runs shall be perpendicular to the direction of the ramp run. Grade breaks shall not be permitted on the surface of ramp runs and turning spaces. Surface slopes that meet at grade breaks shall be flush.

2019 CBC 11B Section: 11B-406.5.6

At an angle

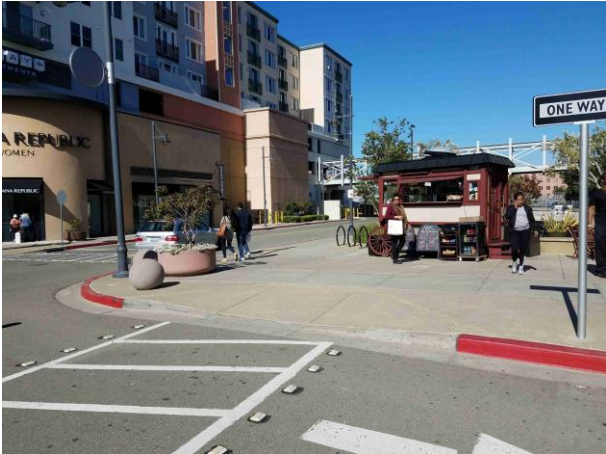
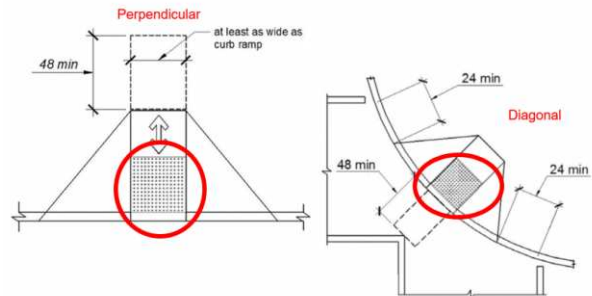
Finding: 4

The detectable warning is missing at the curb ramp.

Detectable warnings at curb ramps shall extend the full width of the ramp run less 2 inches maximum on each side, excluding any flared sides and 36 inches in the direction of travel.

2019 CBC 11B Section: 11B-247.1.2.2,
11B-705.1.2.2

Missing

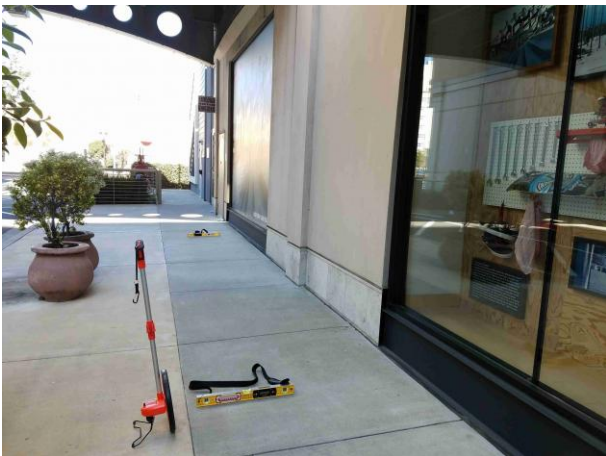
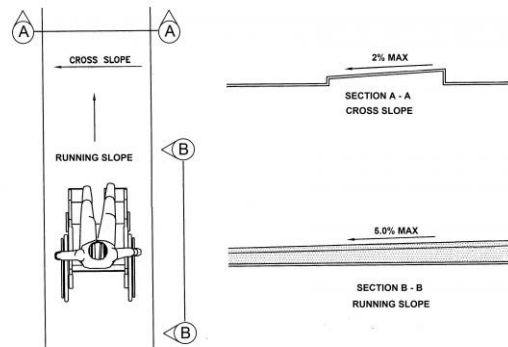
Finding: 5

The accessible path of travel contains cross slopes greater than 2%.

Surface cross slopes shall not exceed one unit vertical in 48 units horizontal (2-percent slope). When the slope in the direction of travel of any walk exceeds 1 unit vertical in 20 units horizontal (5-percent slope), it must be constructed as ramp.

2019 CBC 11B Section: 11B-403.3

3.5% to 4.5% (5 panels)

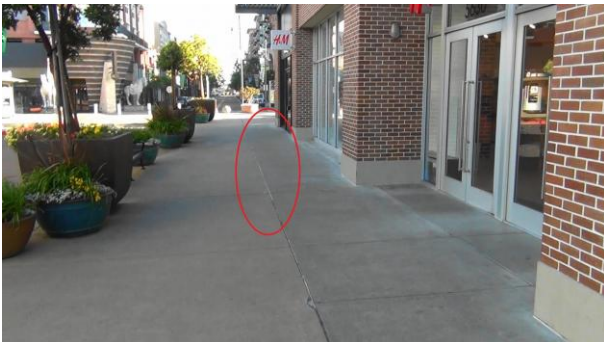
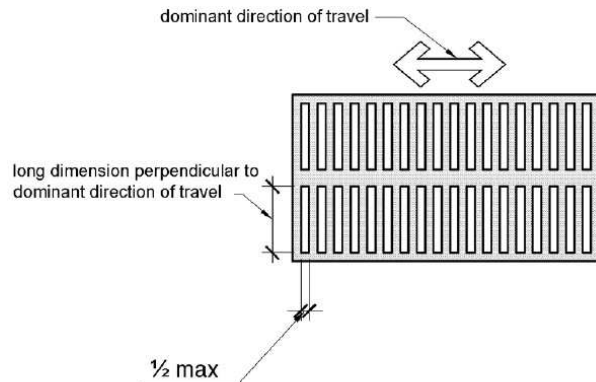
Finding: 6

The concrete expansion joint is spaced greater than 1/2 inch.

Openings in floor or ground surfaces shall not allow passage of a sphere more than 1/2 inch diameter. Elongated openings shall be placed so that the long dimension is perpendicular to the dominant direction of travel.

2016 CBC 11B Section: 11B-302.3

1/2 inch to 3/4 inch
(Typ)

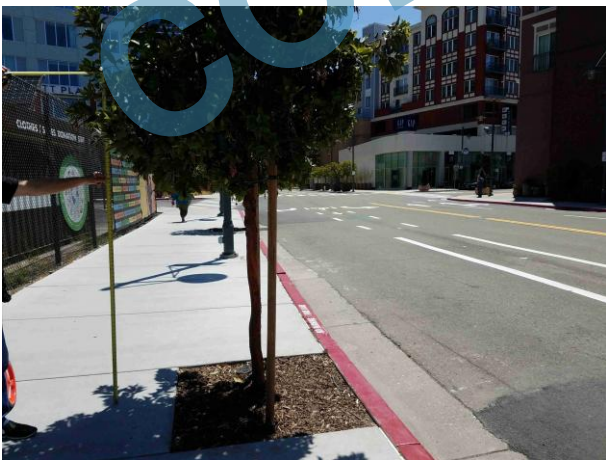
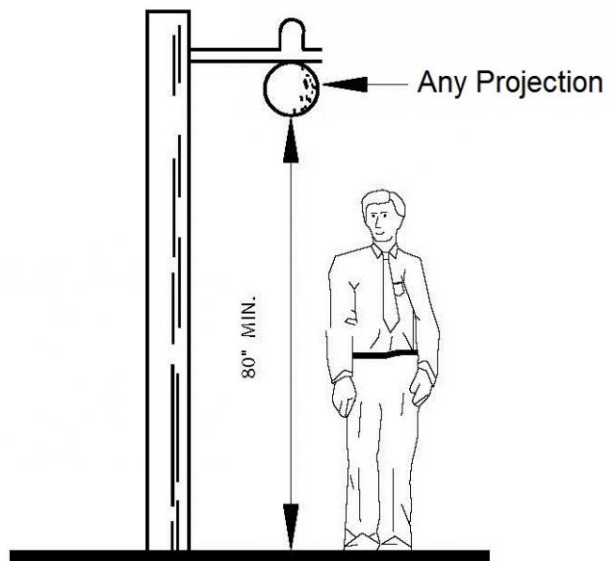
Finding: 7

The tree branches extend down too close to the route of travel.

Any obstruction that overhangs a route of travel must be a minimum of 80 inches above the walking surface as measured from the bottom of the obstruction.

2019 CBC 11B Section: 11B-307.4

70 inches (obstructed - maintenance issue)

Trim back the tree branches to ensure 80 inches minimum of vertical clearance.
